CANADIAN FORCES FLIGHT SAFETY INVESTIGATION REPORT

FINAL REPORT

FILE NUMBER: 1010-C-GXAC
DATE OF REPORT: 11 April 2002

AIRCRAFT TYPE: Bellanca Scout (BL-28)
DATE/TIME: 9 June 2001 1810Z
LOCATION: Markham Ontario
CATEGORY: B Category Air Accident

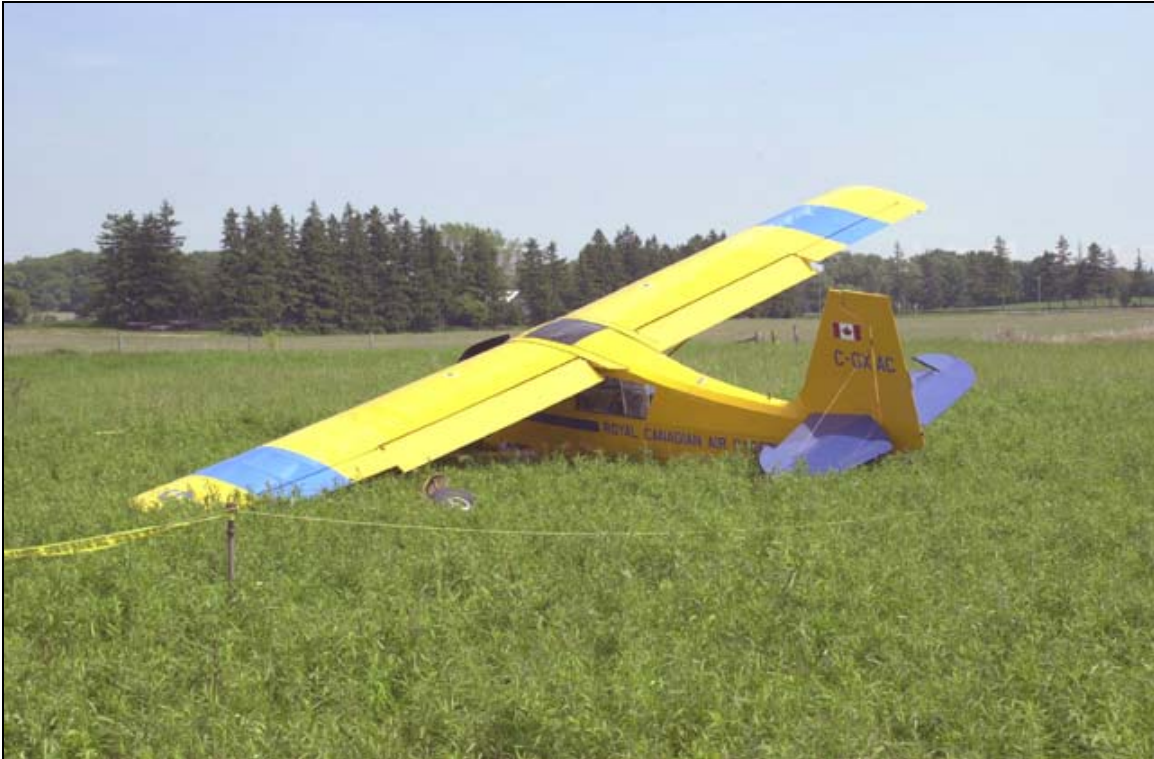
On landing from one of the staff familiarization flights, the tow aircraft was observed to “sink to the ground” from a height of approximately ten to fifteen feet and landed harder than normal. On touchdown, approximately 200 feet past the threshold of the runway, the left landing gear broke at the fuselage attachment point and was dragged along the runway by the stainless steel brake line. The aircraft exited the paved surface of the runway on the left side, 400 feet from the threshold and came to rest on the left wingtip 500 feet from the threshold and 100 feet to the left of the edge of the pavement. (see photo 1)

The aircraft touched down hard on the centreline of runway 27 approximately 200 feet from the threshold where the left landing gear leg broke. The aircraft then drifted to the left side of the runway and exited into the grass area to the south. It came to rest 100 feet to the south of the runway and 500 ft from the threshold, facing east (180 degrees from its original heading). The aircraft remained in one piece except for the left landing gear, which separated from the fuselage in the very last moments and came to rest immediately behind the left aileron.

Photo 1: Final Resting Place

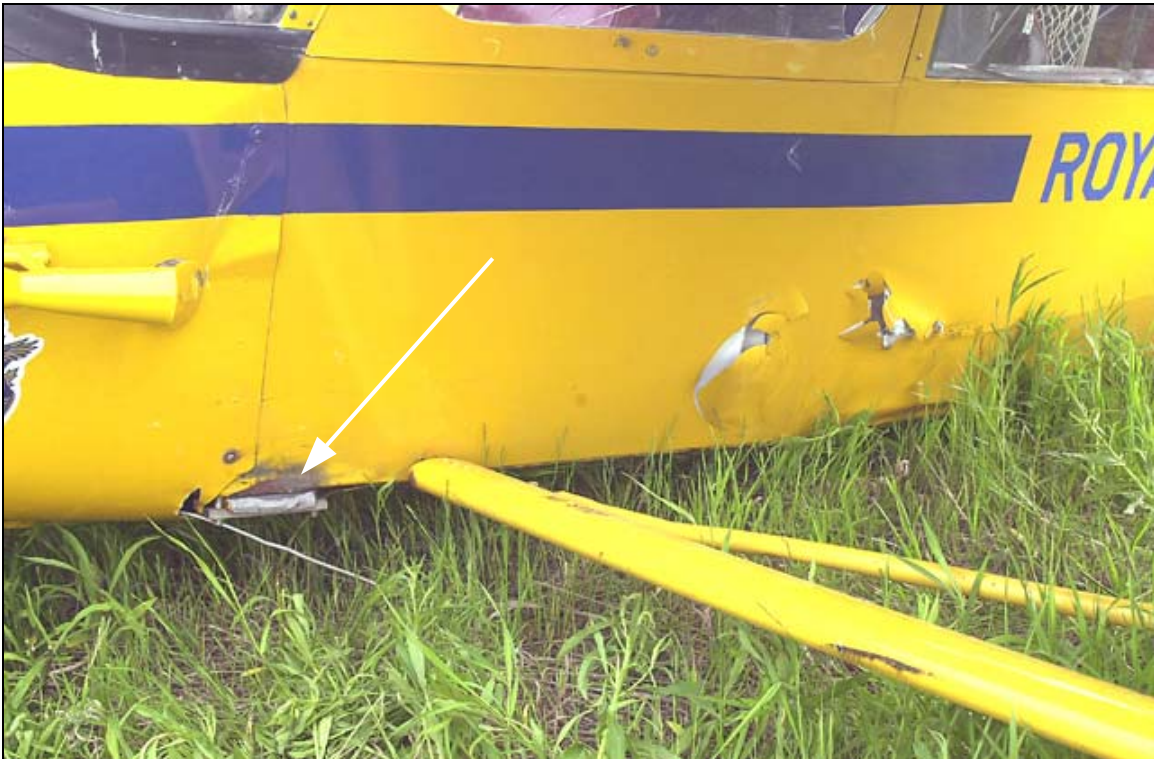
The aircraft received B Category damage. The landing gear leg broke at the bend adjacent to the fuselage (see picture 2). The left main wheel first pivoted upward and contacted the windscreen, fracturing it and then pivoted down and aft rupturing the fabric cover of the fuselage and the side window. The landing gear was then dragged along the runway by the stainless steel brake line causing severe damage to the left brake master cylinder mounted on the left rudder pedal.

The broken landing gear leg was sent to QETE for analysis. The metallurgy specialists at QETE determined that the failure originated at a 0.5mm fatigue crack under the bend in the leg and propagated upward across the thickness of the material. The fatigue zone was assessed to be much too small to be the cause of the failure and the landing gear would have failed even if the crack had

not been present. This indicates that the landing gear must have been subjected to loads well in excess of the design limits.

3.1.10 QETE was able to determine that the landing gear leg broke in overload and that metal fatigue was not a factor.

Photo 2: Broken gear leg and fuselage damage

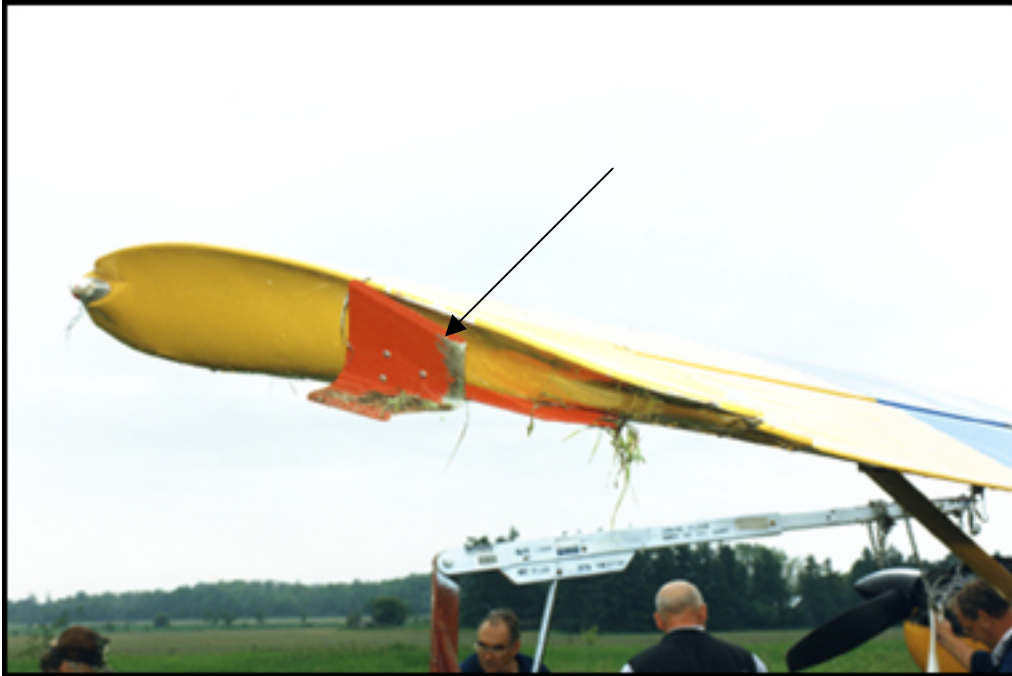
The left wing tip contacted the runway surface causing damage to the “spade” (an aerodynamic balancing device for the aileron) and to the underside of the wingtip (see photo 3). The propeller contacted the soft ground three times after the aircraft left the runway resulting in two bent tips (see photo 4). The engine was at idle at the time the propeller contacted the ground and was sent to a repair facility to be inspected and repaired, as per manufacturer recommendation.

Photo 3: Spade damage

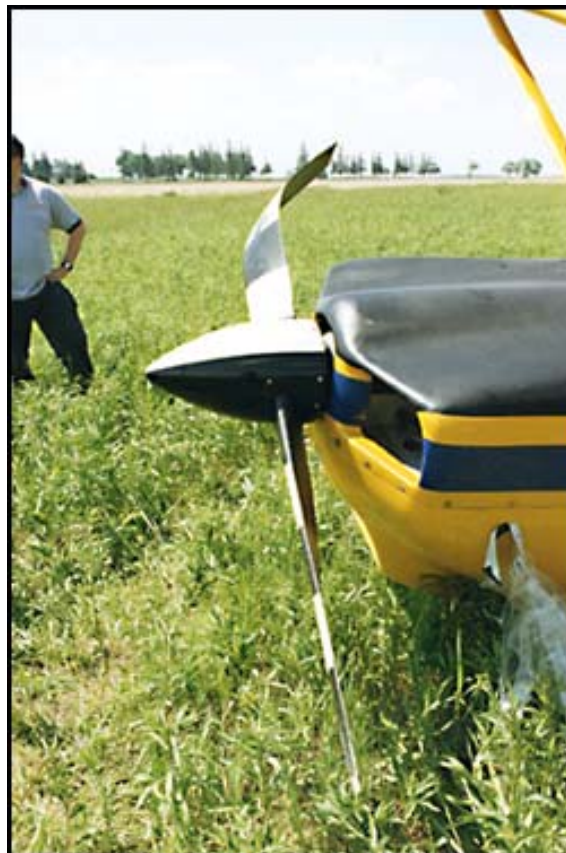
Photo 4: Propeller damage
